**EVALUATION OF FUTURE FUELS IN A
HIGH PRESSURE COMMON RAIL SYSTEM
PART 1 – CUMMINS XPI**

**INTERIM REPORT
TFLRF No. 429**

**U.S. Army TARDEC Fuels and Lubricants Research Facility
Southwest Research Institute® (SwRI®)
San Antonio, TX**

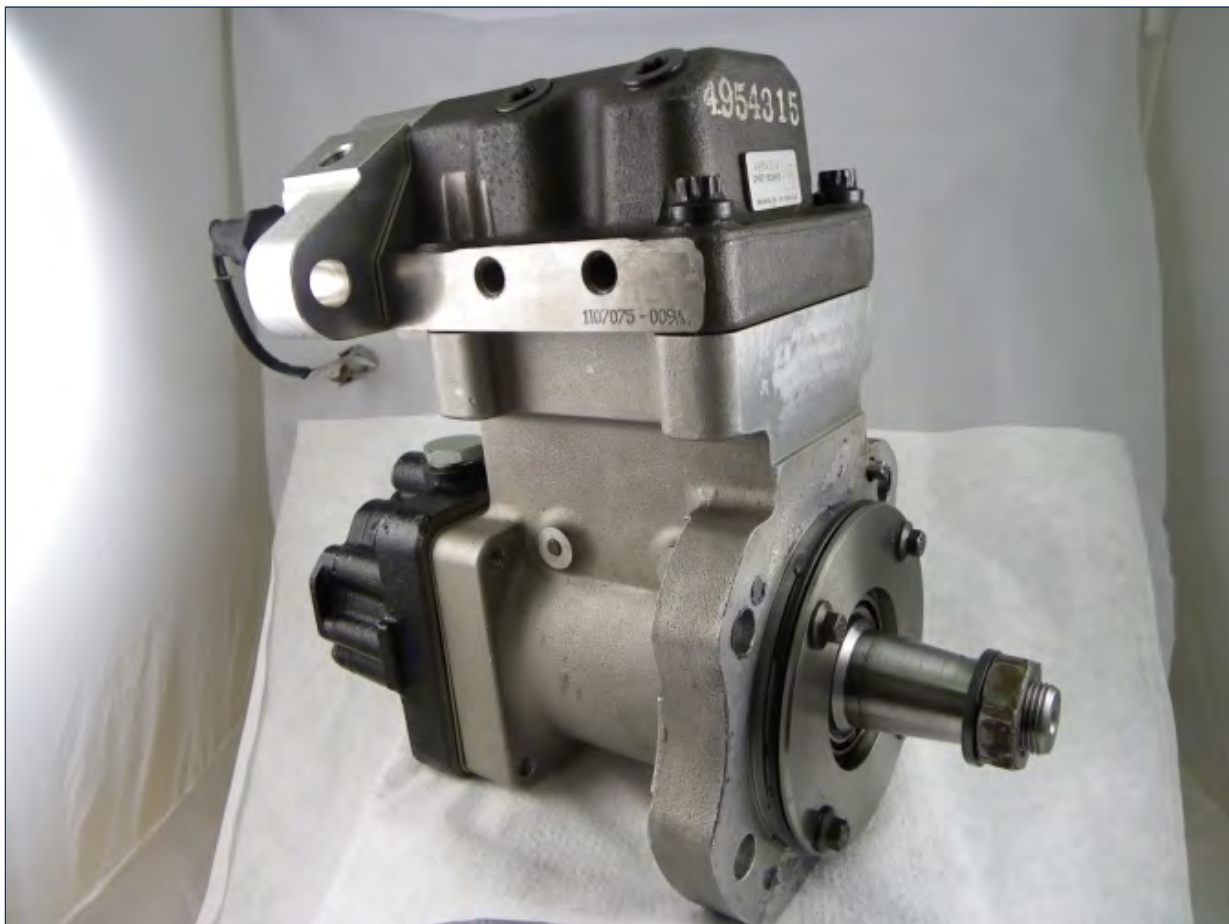
Figure 1. XPI Pump – Drive Input

The XPI system was developed jointly between Cummins, Inc. and Scania. Primarily targeted for Cummins midrange and Scania heavy duty applications, an oil-lubricated fuel pump allows the system to reach rail and injection pressures of up to 30,000 psi. It is operated at half engine speed to reach a rated condition of 1050 rpm (based upon the engine calibration used for testing). The XPI high pressure pump features a combination of low pressure gear pump and high pressure piston pump driven by a common shaft. The full pump is shown in Figure 1 and Figure 2. It should be noted that the pump shown was in a state of partial disassembly for information purposes and that photographs are of the pump used in low temperature ULSD testing.

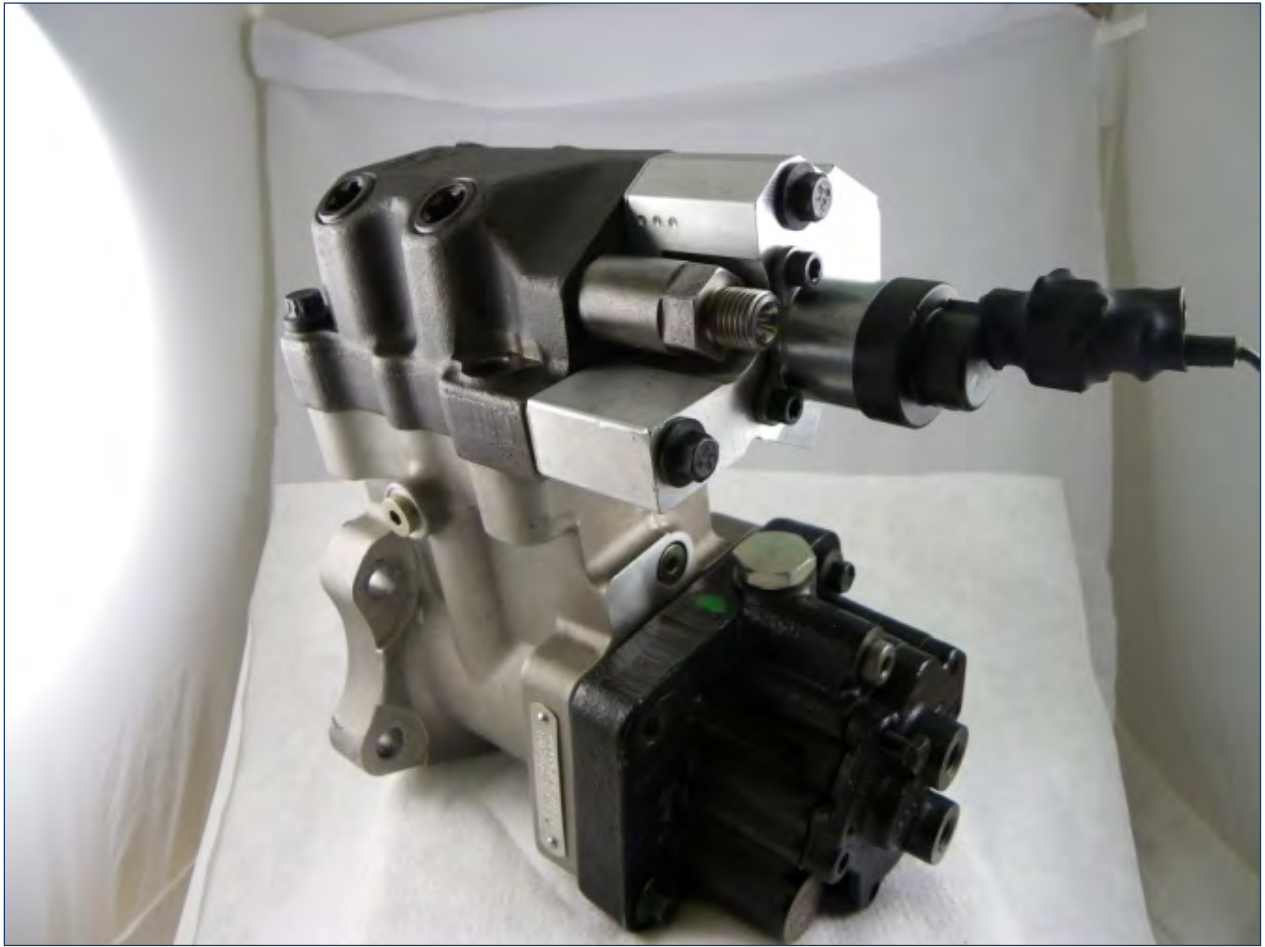
Figure 2. XPI Pump – Gear Pump Side

Power is provided to the pump via the tapered shaft located at the front. The shaft gear, not shown, meshes with the cam gear on the engine to provide speed and timing. Lubricating oil is provided through an orifice on the front of the pump from the engine oil galley and is allowed to drain out through the front bearing. The two cams on the shaft each feature three lobes which drive the high pressure pistons. The combination of two cams with three lobes each allows the pump to impart new fuel into the high pressure rail as each injector fires. Figure 3 shows the oil-lubricated portion of the pump with other components removed.

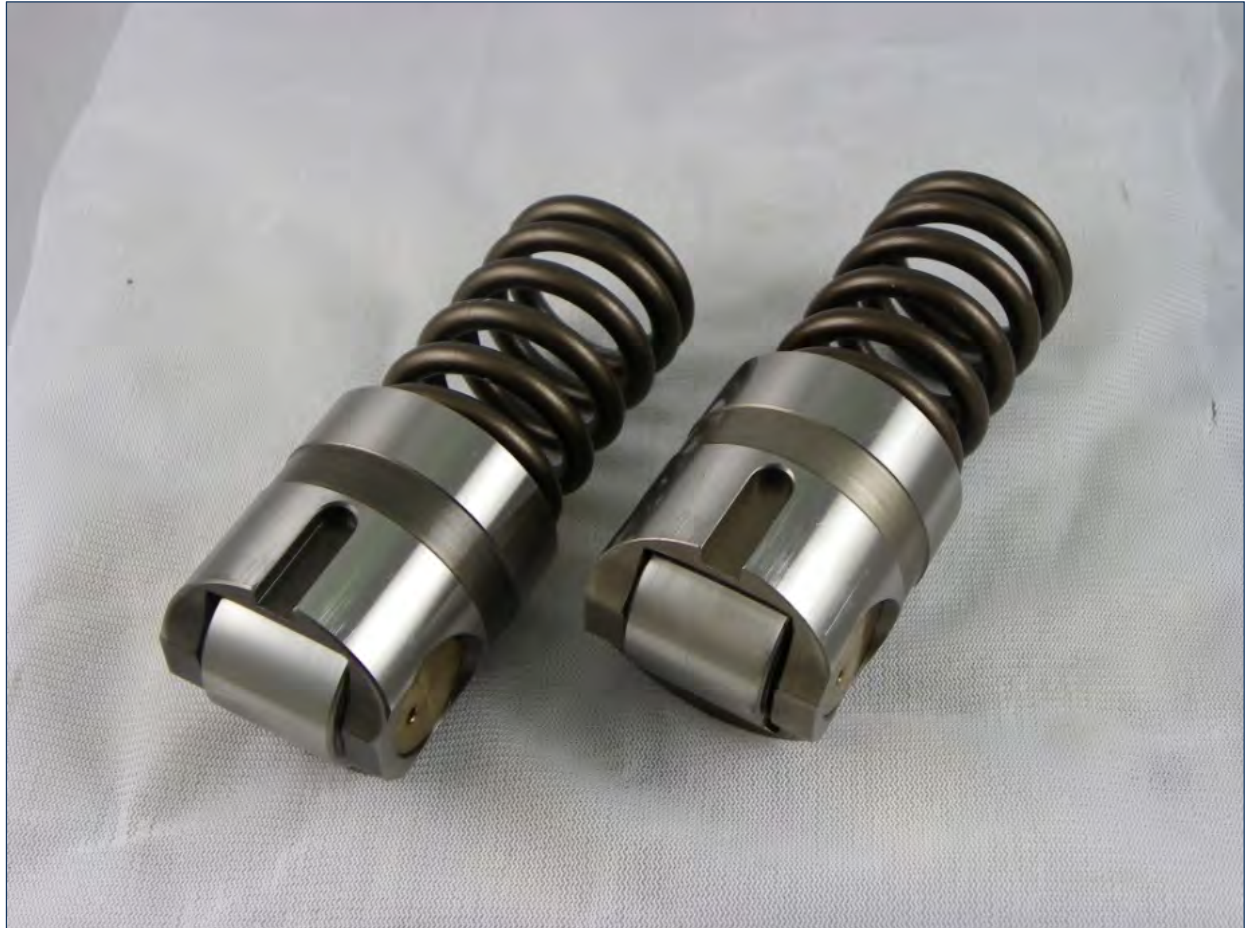
Figure 4. Roller-Followers

Each spring sits in a roller-follower tappet as shown in Figure 4. Oil flowing from the inlet orifice on the front of the pump passes through the roller on the bottom of the tappets to maintain lubrication throughout the pump housing.

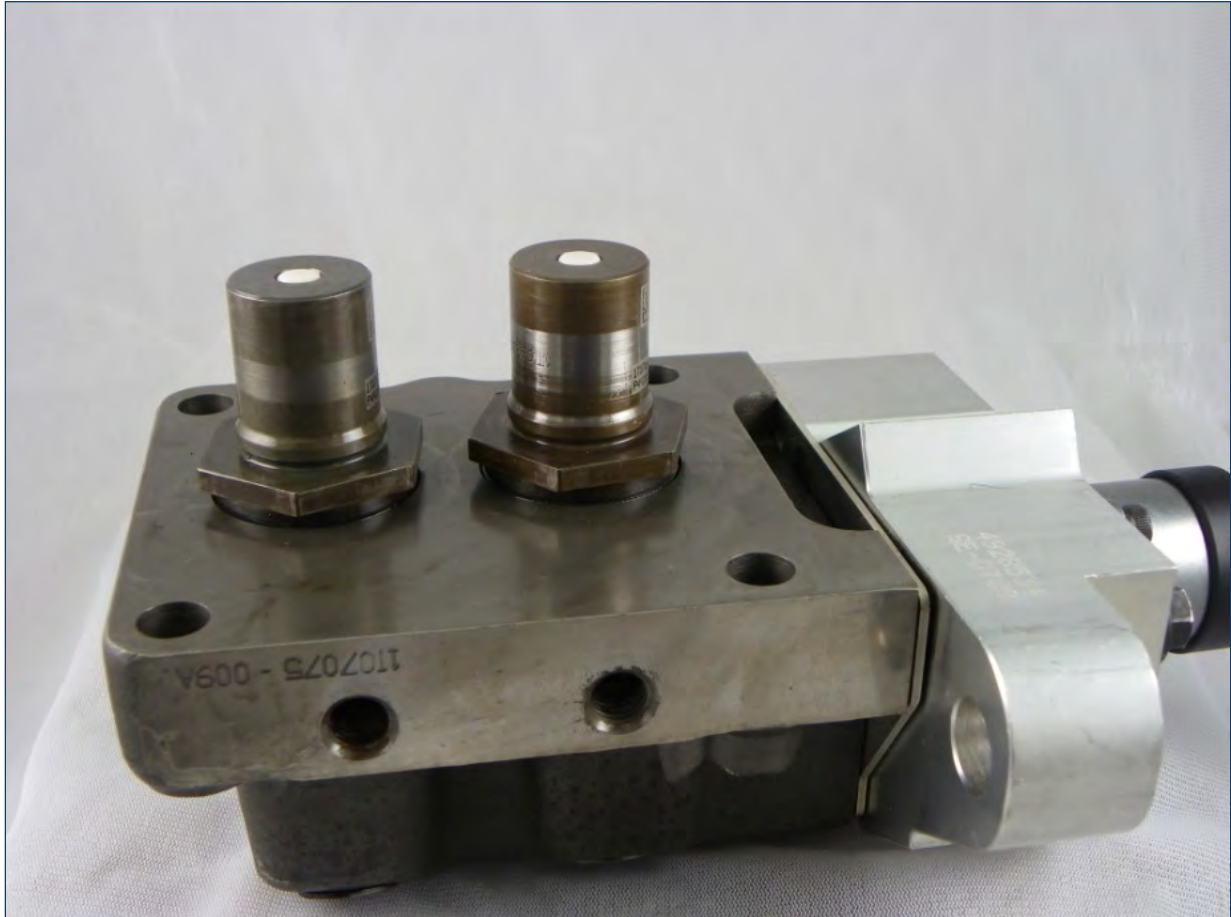
Figure 5. High Pressure Pump Head

These springs are compressed against the underside of the pump head to maintain contact with the pump camshaft. The underside of the pump head is shown in Figure 5.

The two barrel retainers located on the underside of the pump head hold the ceramic plungers which develop the high pressures within the pump. The plungers are driven into the barrels by the tappets as the shaft turns. They are forced back out by fuel from the low pressure gear pump using a system of check valves located in the pump head. This is illustrated in Figure 6.

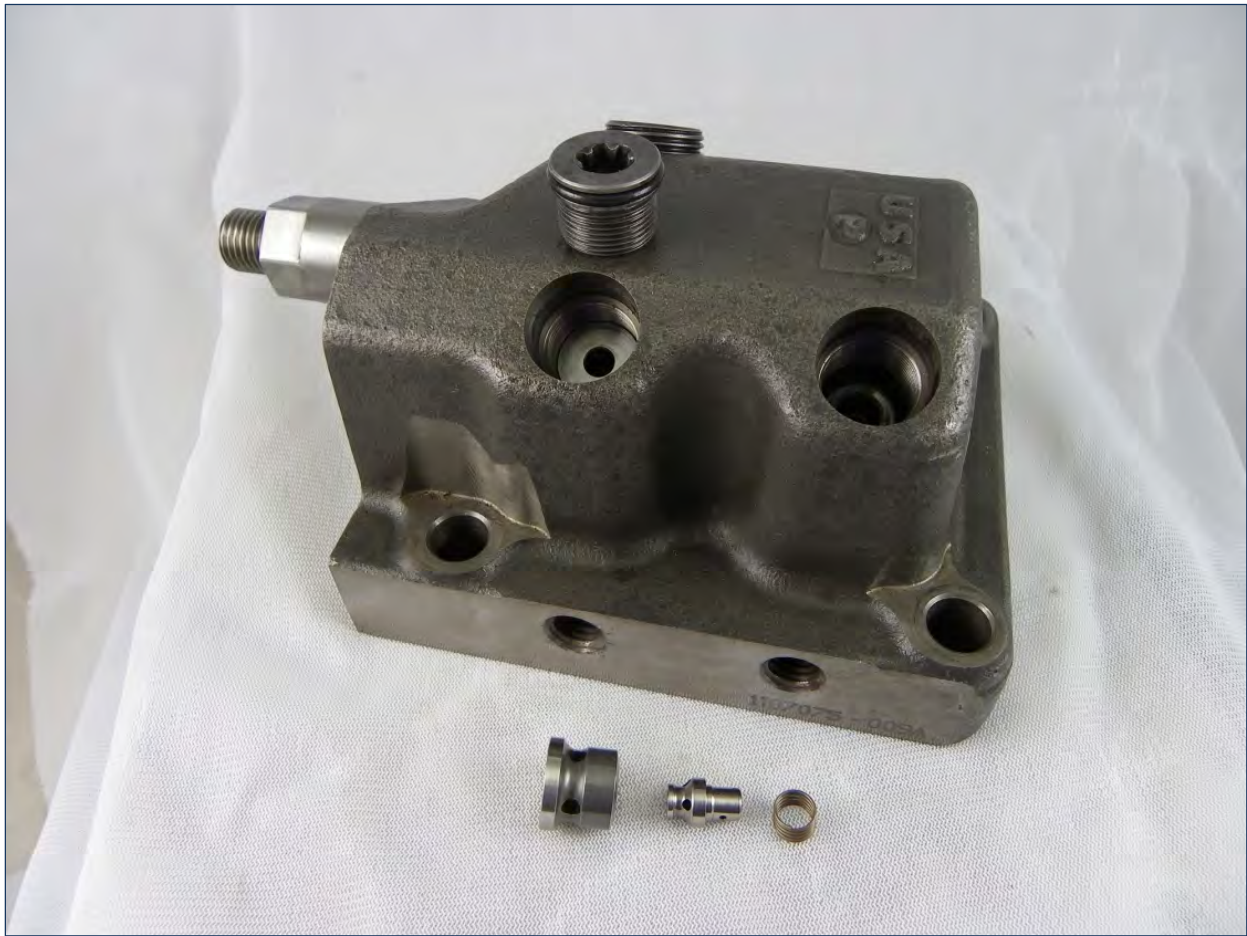
Figure 7. Inlet Check Valves

Figure 7 shows the lower pressure, inlet check valves within the pump head.

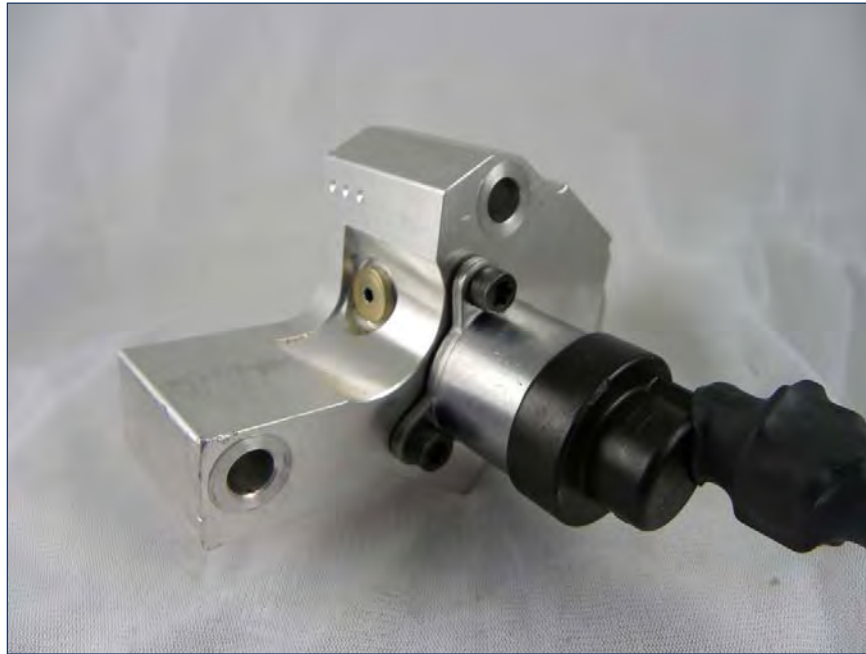
Figure 8. Control Manifold Portion of Pump

Fuel enters this portion of the head through a volume control manifold located to the rear of the pump head. This can be seen in Figure 8. Figure 9 shows the gasket with fuel passage between the two sections of the pump.

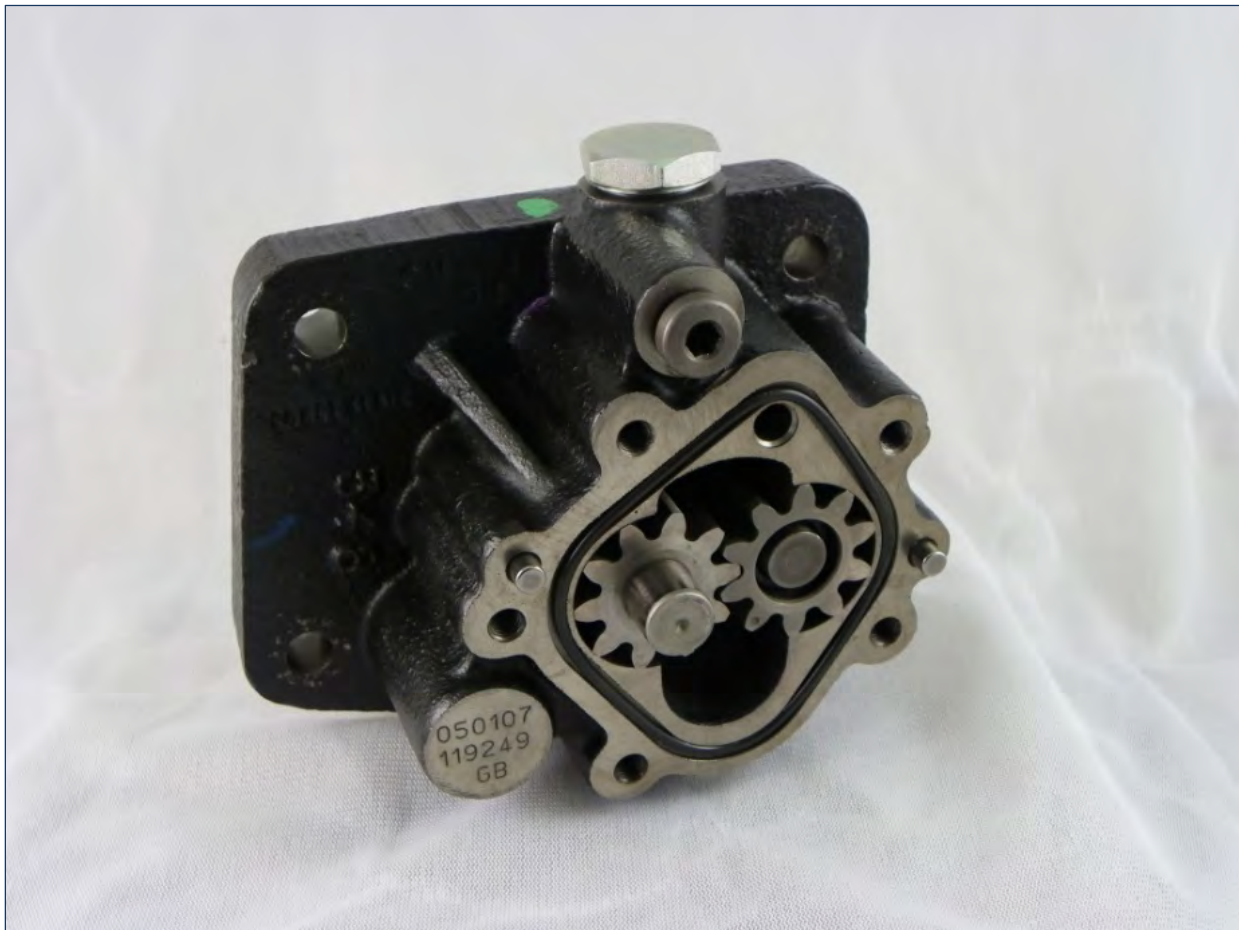
Figure 10. Low Pressure Gear Pump

The XPI system uses the electrically actuated control valve to direct fuel supplied by the low pressure side into the inlet of the pump head or to the bypass and return line. The low pressure gear pump, located on the rear of the pump body, draws fuel from the tank and pushes it through the final filter before entering the volume control area. Figure 10 shows the pump with the rear cover removed. While the low pressure pump is driven off of the main, oil lubricated shaft, the gears themselves are fuel-wetted surfaces.

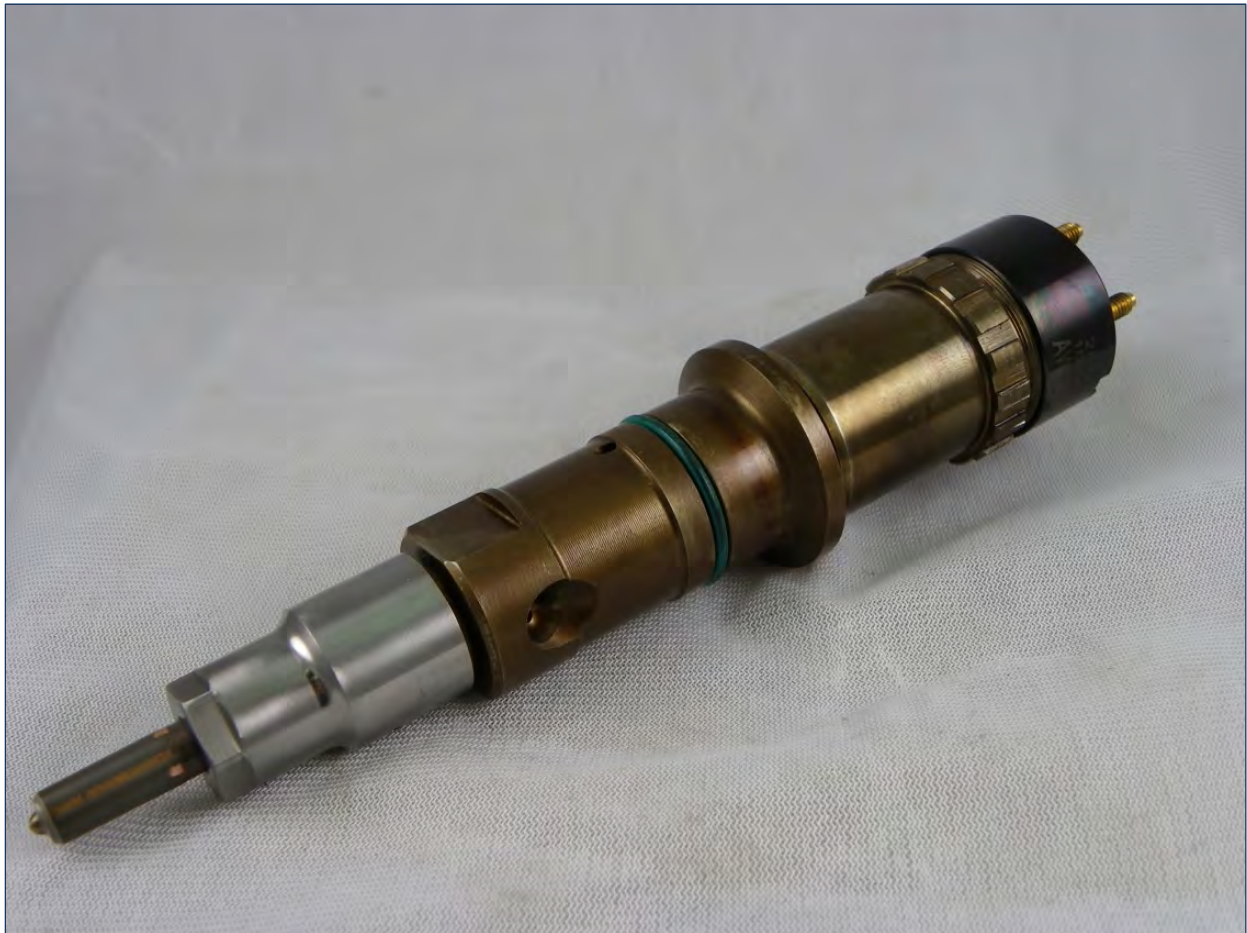
Figure 12. XPI Fuel Injector

The XPI system injectors are solenoid controlled and able to provide multiple injection events per cycle. Figure 12 shows an injector with the hold-down clamp removed.

High pressure fuel from the rail enters the injector via a quill tube through the cylinder head. The tube is held in place against a tapered hole in the side of the injector to form a high-pressure seal. Fuel enters the injector and fills internal passageways to act as a hydraulic fluid. From there, it is either directed through the injector tip into the cylinder, or allowed to flow out of the injector and back through the cylinder head as bypass fuel.

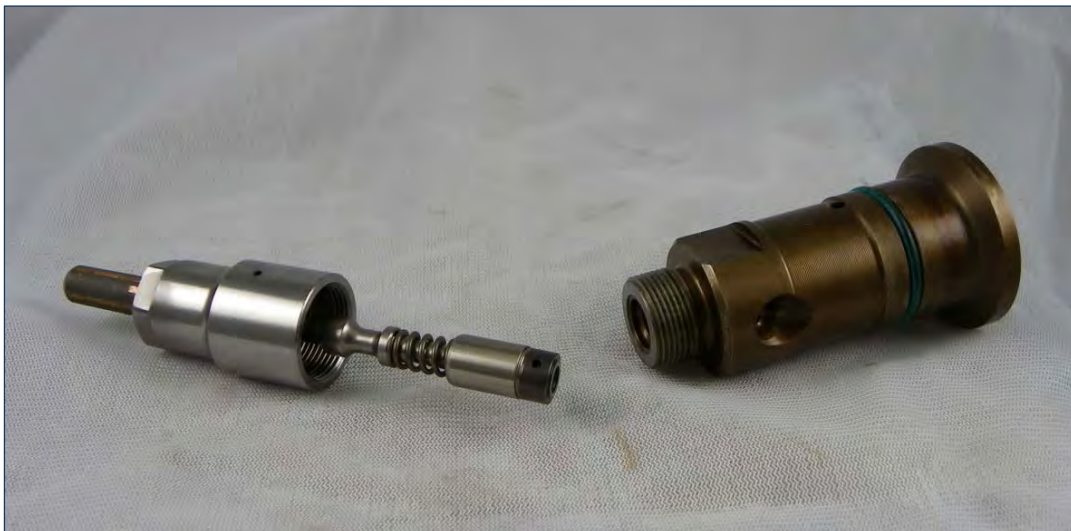
Figure 13. Lower Injector Disassembled

The injector body is made primarily of three sections. The lowest section holds injector tip and part of the needle. The upper half of the needle resides in the middle section of the injector body as can be seen in Figure 13. The needle, removed, can be seen in Figure 14.

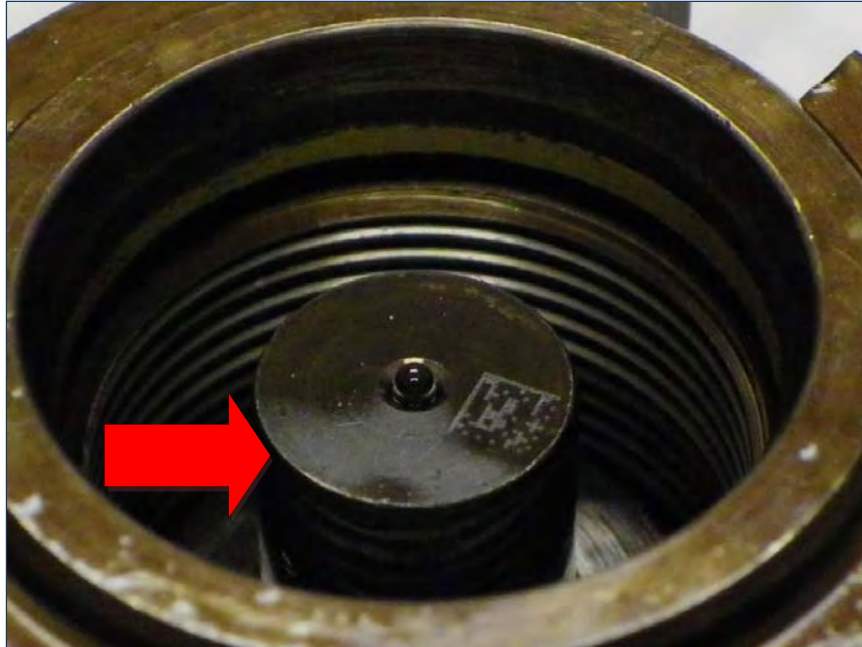
Figure 15. Control Ball

The middle section of the injector body also contains hydraulic components which allow the needle to lift. One of particular interest is a small ball which, when seated, prevents the flow of fuel and closes the injector. This part, in place, can be seen in Figure 15. Figure 16 shows the ball next to a common penny for size comparison.

When the control element is energized, the ball is allowed to lift off the lower seat and fuel flows past it from the lower section of the injector. This reduces the fuel pressure on the upper side of the needle and allows lift, letting fuel flow through the tip. When current is removed, the ball is moved back into place by a combination of spring force and fuel pressure in the upper section of the injector.

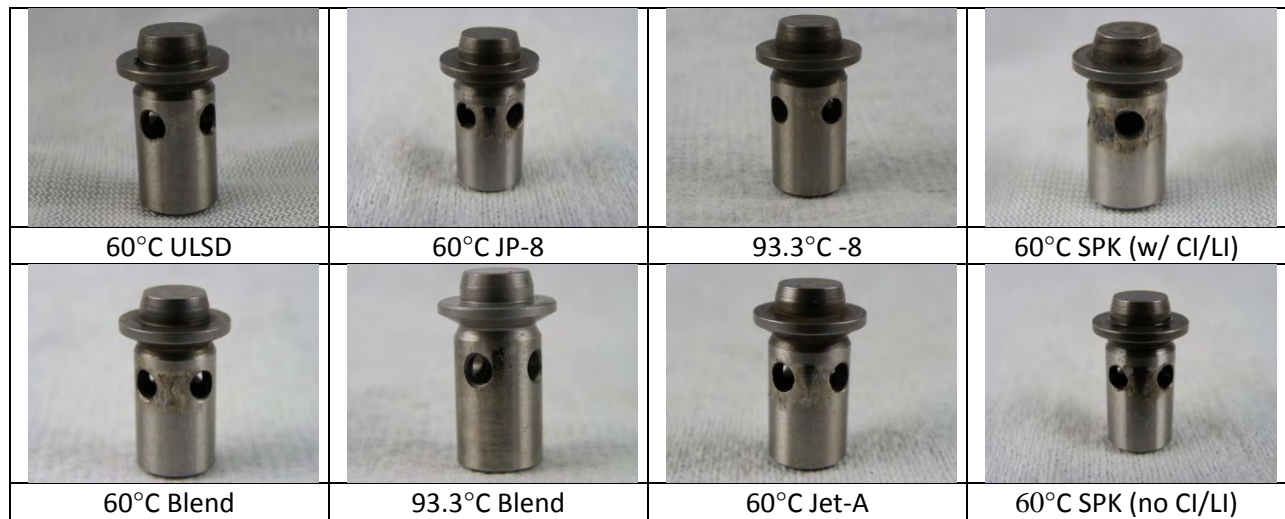
Figure 30. Pressure Relief Valve Side A

A relief valve in the gear pump prevented excess downstream pressure from building at the filter element. The two locations which showed polish and wear are displayed in Figures 30 and 31. A spring, held in place by the plug on top of the pump, keeps the valve seated until there is sufficient downstream pressure to overcome the spring force. When operating, the valve likely spends a substantial amount of time fully or partially open, vibrating in place as the spring and pressure forces balance each other. While this is occurring, two spots on the cylinder developed substantial polishing in most cases. The locations were on opposite sides of the piece for each test, indicating that the component moved through its bore at a slight angle. For the two tests

conducted at elevated temperatures, a lesser degree of wear was noted on this component. One possible explanation for this is that the lower viscosity fluids relieved more pressure through leakage which then resulted in a reduced actuation of the relief valve. The two tests using the SPK test fuel, additized and neat, produced very similar polish patterns despite the difference in lubricity.

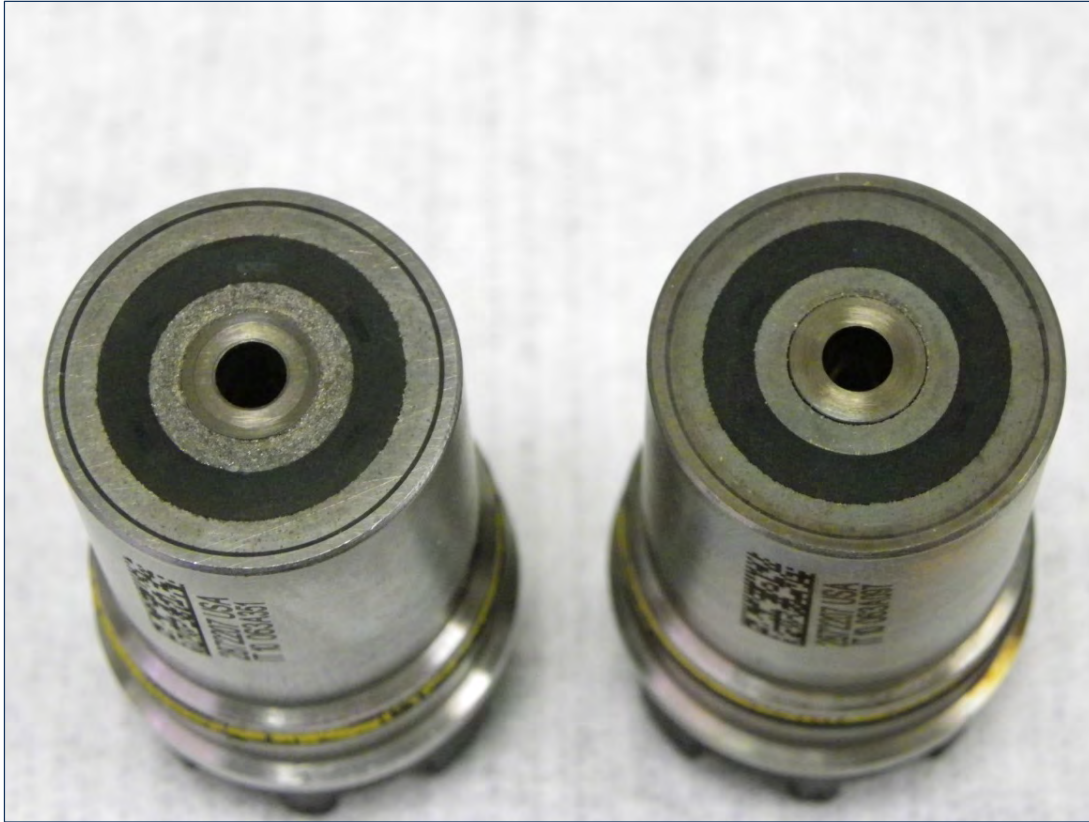
Figure 36. Solenoid Comparison – Suspected Failed (Left) and Typical (Right)

The location likely responsible for the particles is the bottom side of the solenoid. Figure 36 shows the difference in appearance between the suspect injector (left) and normal injector (right) at the end of the test.

The metal immediately inside of the black insulating material is substantially rougher in texture in the failed component. While this is a location that should not come into direct contact with the component below it, matching wear marks indicate that some degree of contact did occur. Also, the color of the particles collected from the plunger are consistent with the area in question. The only way for this to have happened would be for the plunger within the solenoid to have been forced further in than it normally travels, not an issue likely related to fuel viscosity or lubricity effects. Additionally, the timing of the failure, early in the test, coupled with the lack of repeated occurrence within the other injectors of this and other tests, lead to the conclusion that it was an isolated incident related to the components themselves rather than the fuel used.

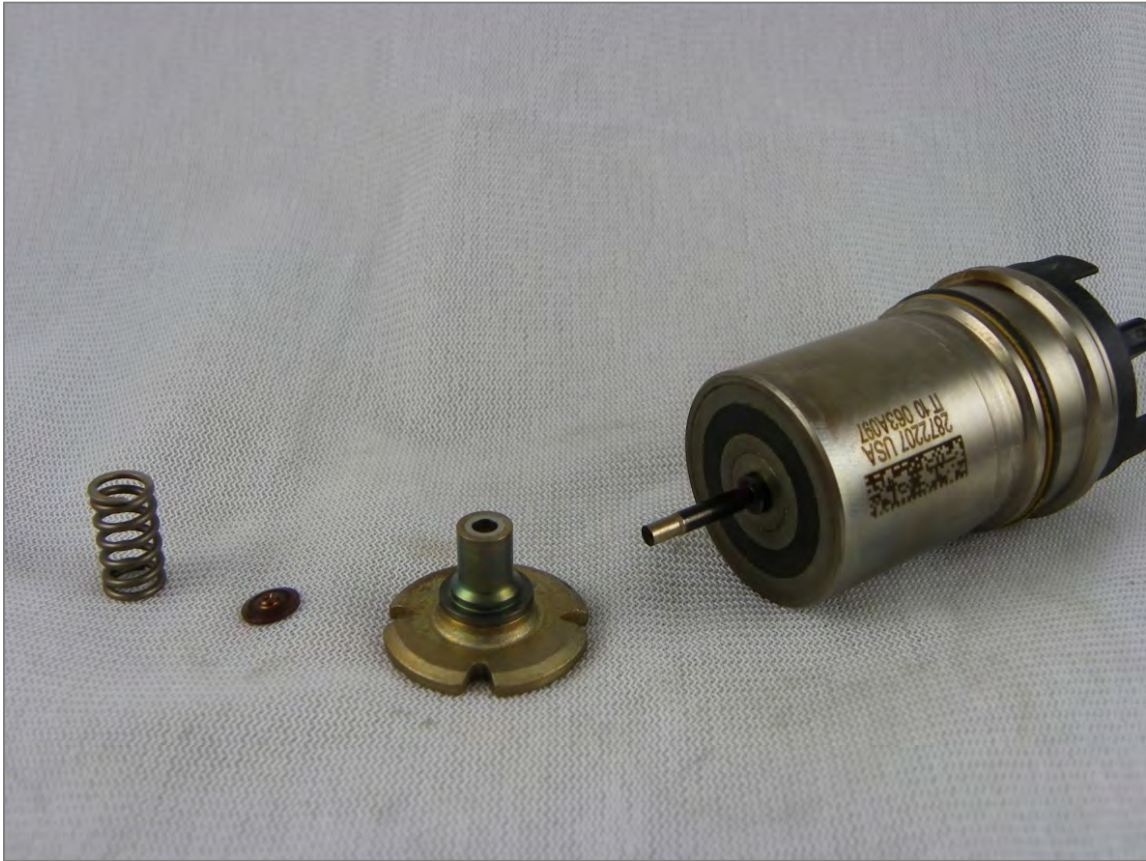
Figure C-14. Upper Injector Components (Typical)

It was concluded that injector #4 experienced a failure during the JP-8 test. Photos for this test are shown for both the failed unit one representing a typical condition of the other five injectors. While disassembling the unit, it was found that the solenoid plunger seemed to be seized within its bore. After removal, the plunger would not slide back into the bore as it would in the other injectors. Since no issues of a similar nature were found in the other injectors or the pump, it is assumed this the failure was related to hardware and not the fuel used for testing.

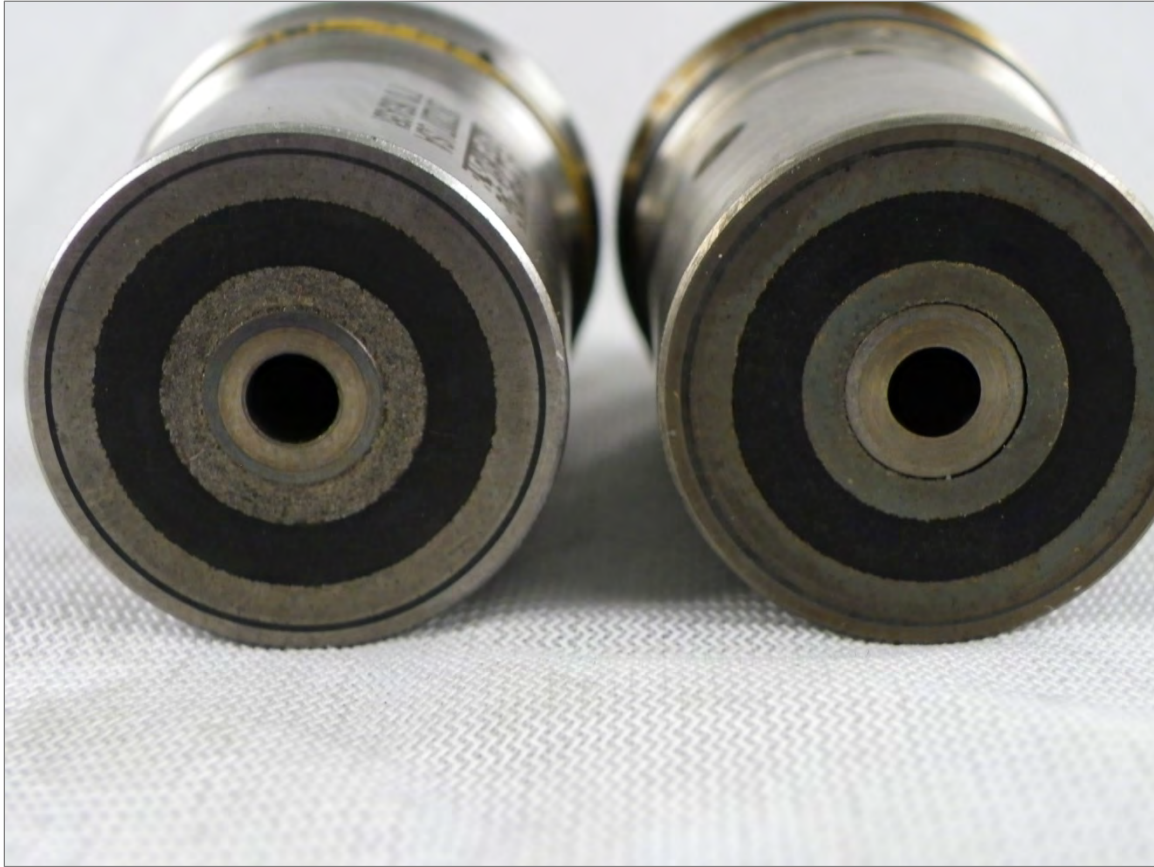
Figure C-16. Solenoid Units, Failed (Left) and Typical (Right)

It was observed that the material in the solenoid of the failed injector had a rougher and porous surface appearance compared to that of the typical unit. Additionally, the inside surface of the bore (not shown) had a dull appearance rather than the highly polished surface found in others.

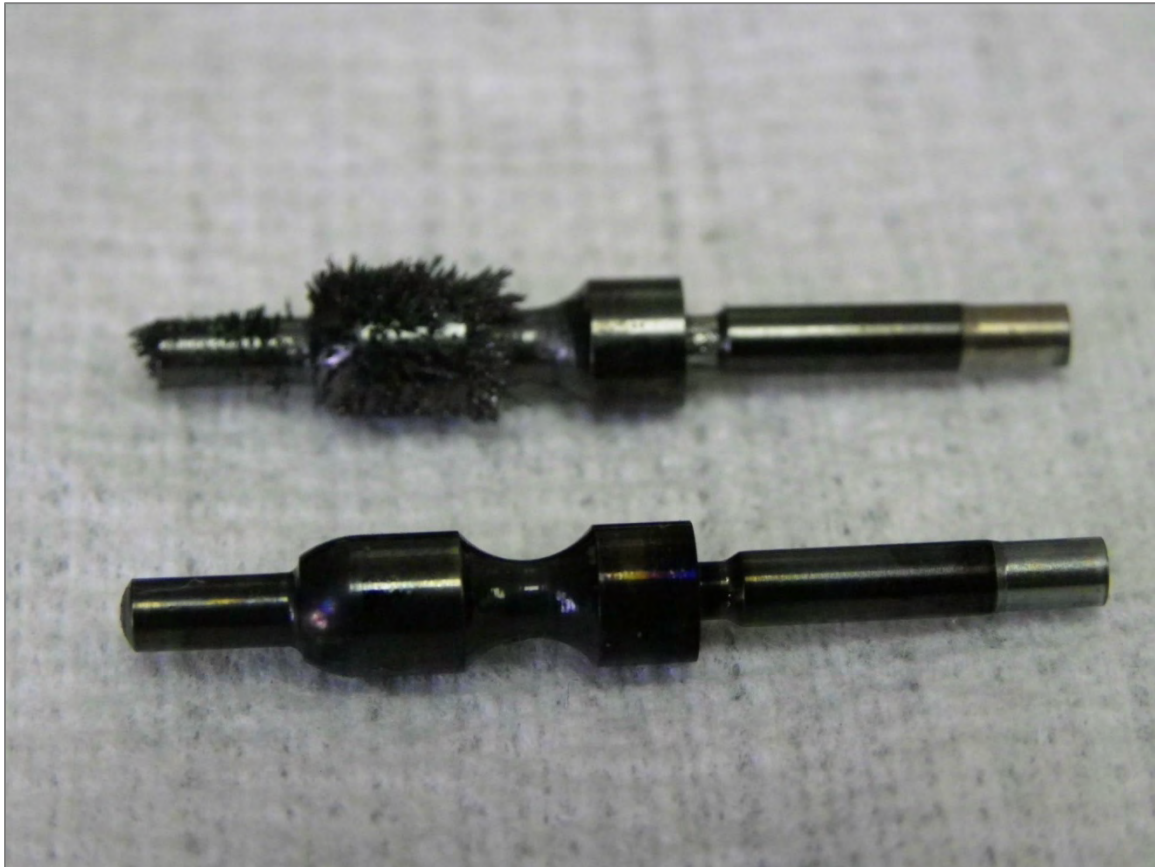
Figure C-17. Solenoid Plungers, Failed on Top, Typical Below

Upon removal, metallic filings were found on the plunger. It should be noted that the filings are standing out in Figure XX due to the magnetic nature of the piece. While still wet with fuel, the filings were mainly collected between the two wider sections and the top of the plunger. Shown along with plunger from the failed unit is another from the JP-8 test typical of the remaining injectors.

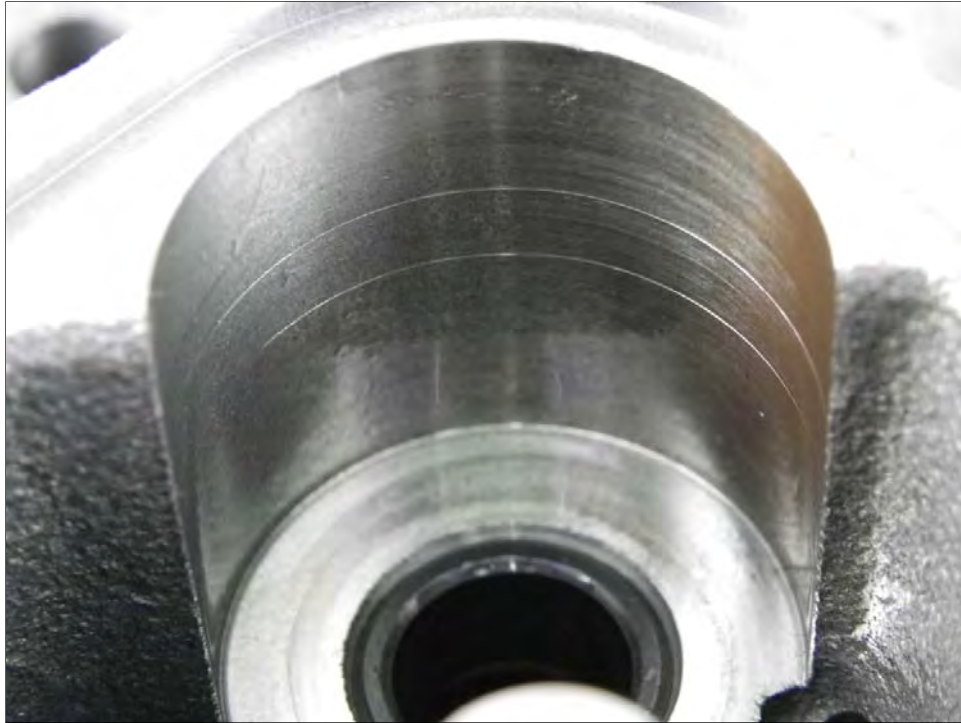
Figure E-10. Gear Pump Housing Wear

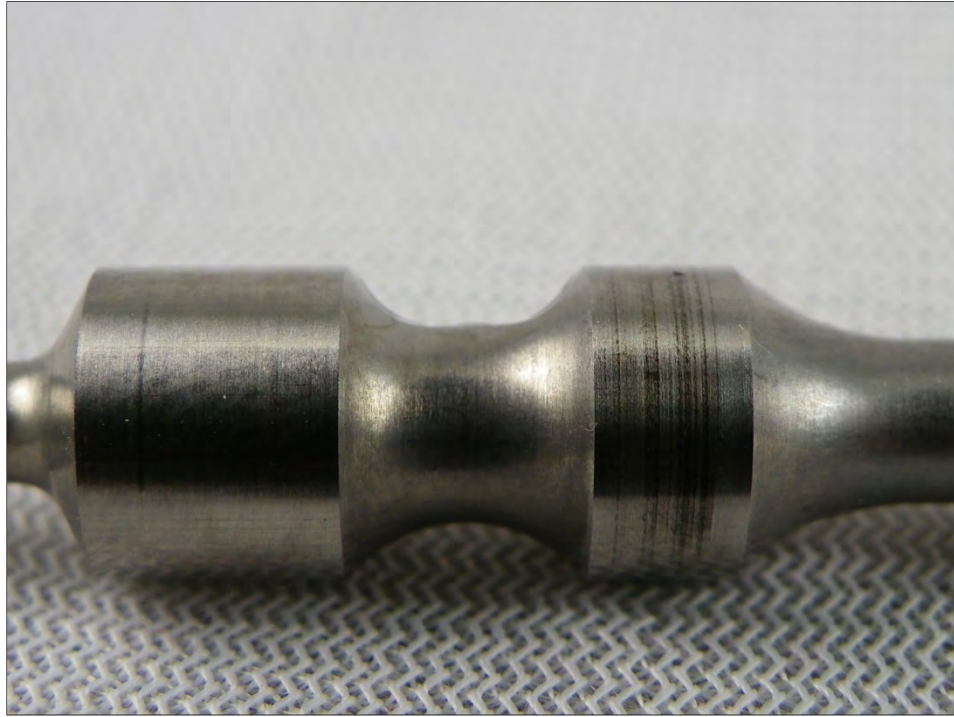
Figure E-20. Injector Needle Scuffing

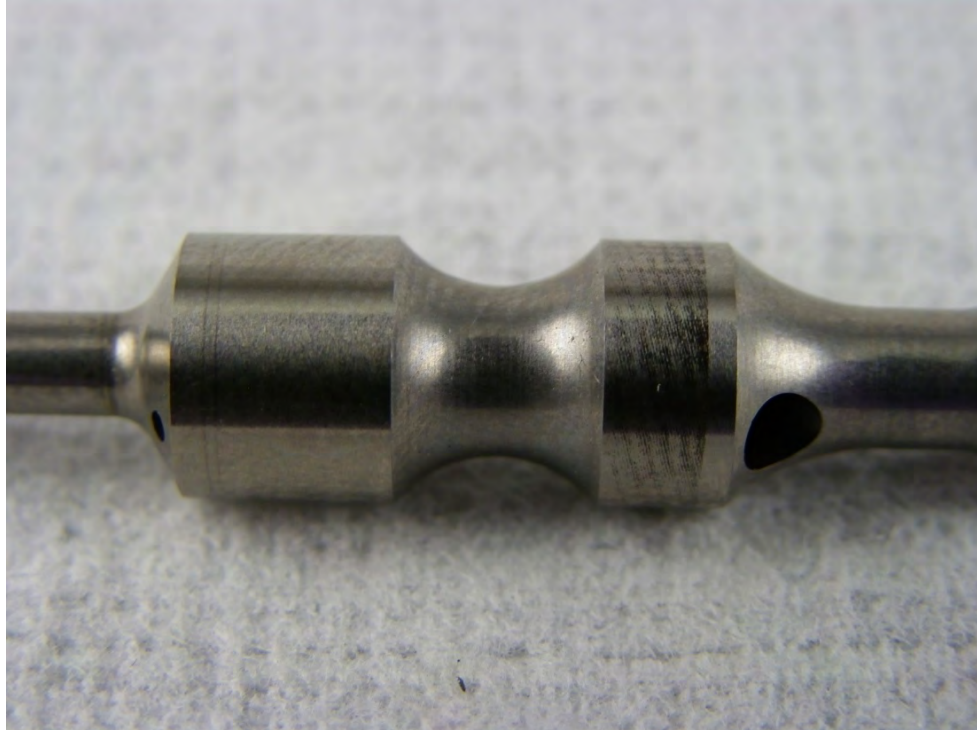
Figure F-20. Injector Needle Scuffing

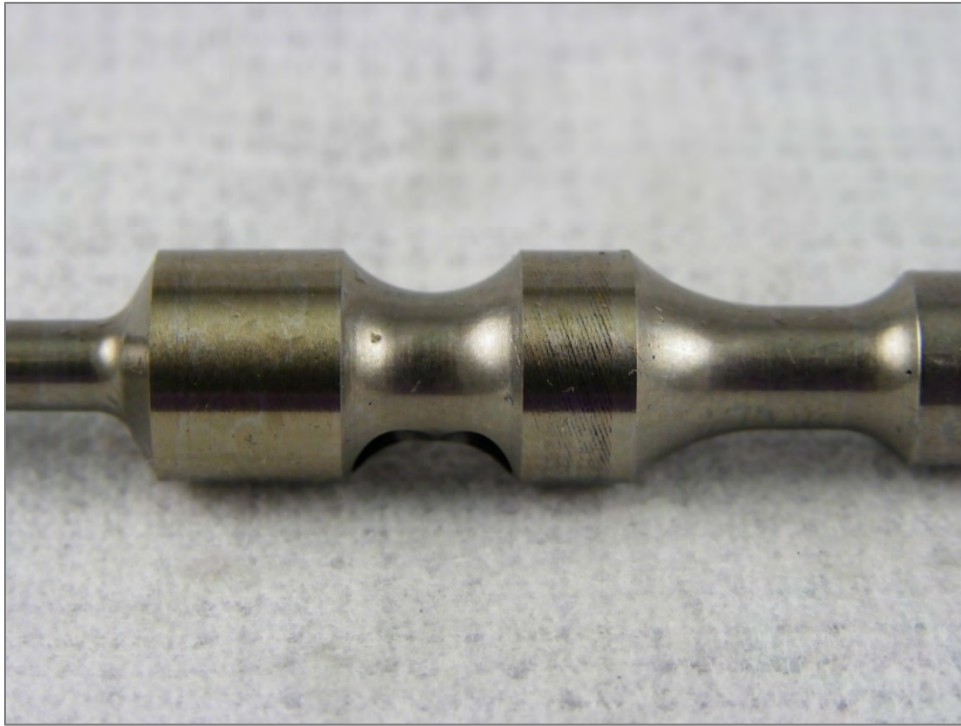
Figure G-21. Injector Needle Scuffing

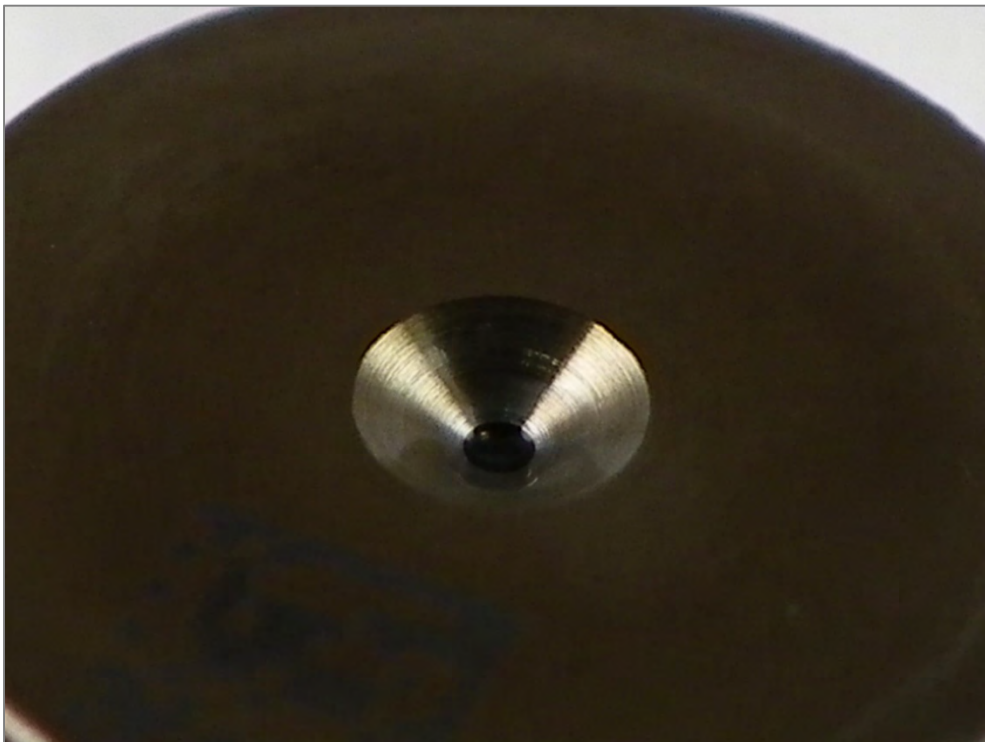
Figure I-17. Injector Needle Scuffing
